Vickery Facility
Waste Management Company
156 State Route 412
Vickery, Ohio 43464
19-547-7791
Vax: 419-547-6144

Tank System Release Report

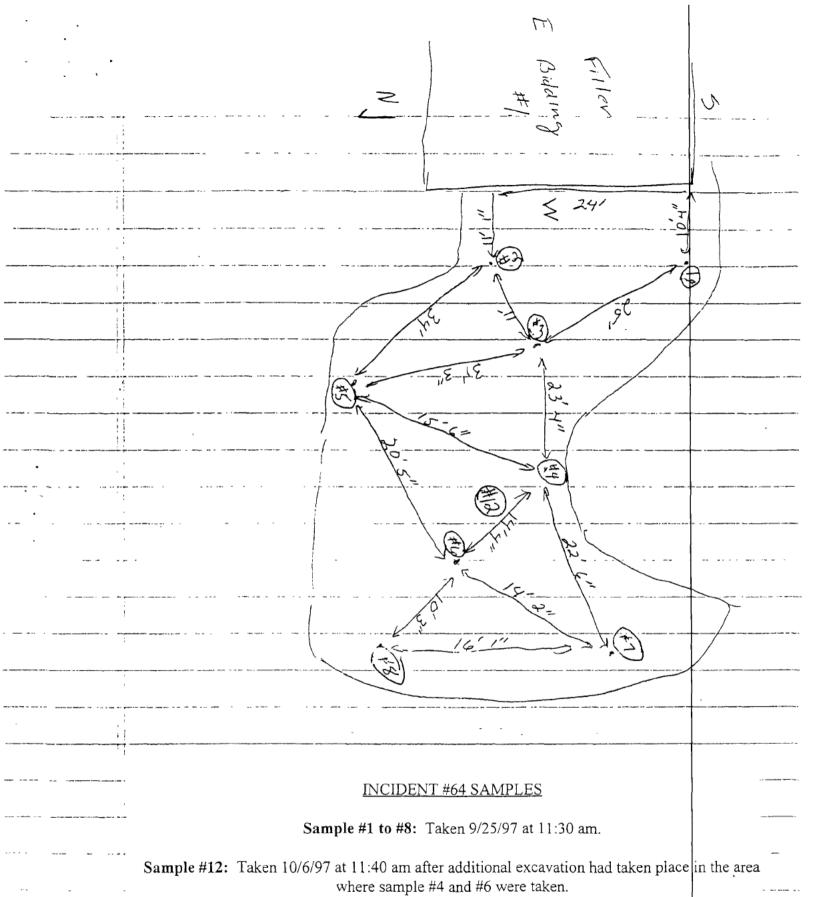
SKETCH OF SAMPLES AND SAMPLE RESULTS FOR 9/25/97 AND 10/6/97 SAMPLING

(9) Source of Release: Product line broke at check valve which allowed waste to flow backwards through the broken line.

- (10) How was Release Stopped: Transfer of material was stopped immediately.
- (11) Cause of Release: Line broke at the check valve. Waste from the filterpress drained backwards through the broken line.

- (13) Description of monitoring or sampling: At the completion of excavation, soil samples were taken and are being analyzed for RCRA Metals. The results will be submitted under separate cover. Surface water beyond the spill area was checked with pH paper and was found to be neutral.

- a. The admix line has been repaired.
- b. The bracing of the line has been changed.
- d. A swing- check valve has been installed in place of the ball-check valve.
- e. The admix feed pump relief valve setting has been recalibrated.
- f. A dampener has been installed on the discharge line of the admix feed pump.
- g. An alarm is being installed in the sump within the building which will signal to the Control Room.

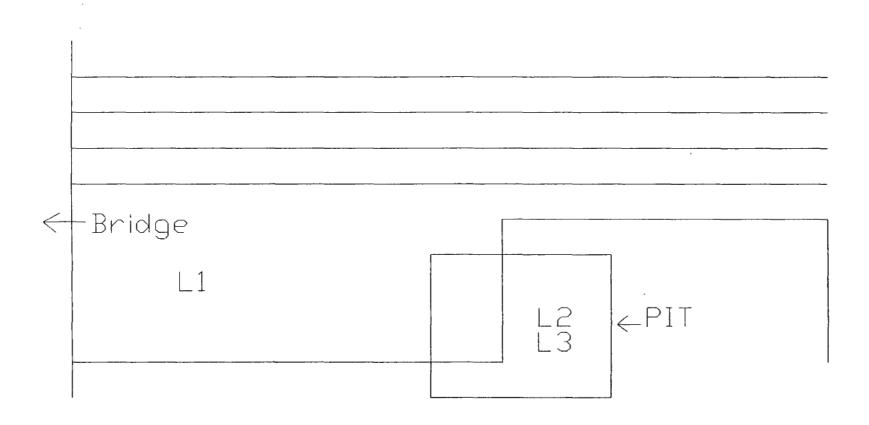
On July 11, 1997, Chemical Waste Management, Inc. (CWM), Vickery submitted a tank system release report. As noted in Section 15 of that report, samples were taken of the water in the pit. Enclosed are the analytical results for those samples which were analyzed for Total Lead and Hexavalent Chromium. Enclosed also is a drawing showing the sampling locations.

L1 Sample taken at 10:09 am 6/26/97 L2 Sample taken at 10:09 am 6/26/97 L3 Sample taken at 8:30 am 7/2/97

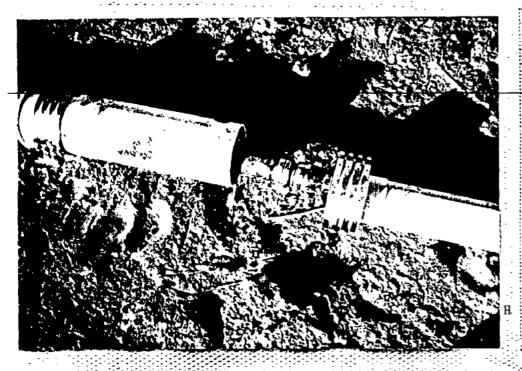
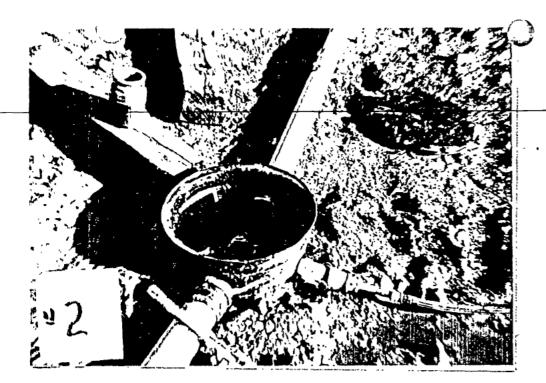
Photographs A through H were taken January 13, 1989.

The three detection pots (See Technical Summary - Leak Detection and Support Photo 2 of November 11, 1988 Certification) were changed to facilitate not only leak detection, but temperature construction and/or expansion. The modified pots are:

- 1) 54" x 36" x 42" deep concrete box structures which the outer 4" diameter pipe is sleeved through the structure walls, and
- The 2" diameter high density polyethylene inner carrier pipe is connected via a thick walled wire core rubber hose which is looped to approximately 2 ft. diameter and connected to the carrier pipe with hose clamps. The three modified leak detection/thermal expansion structures are at the same locations, original pots and photographs are attached.

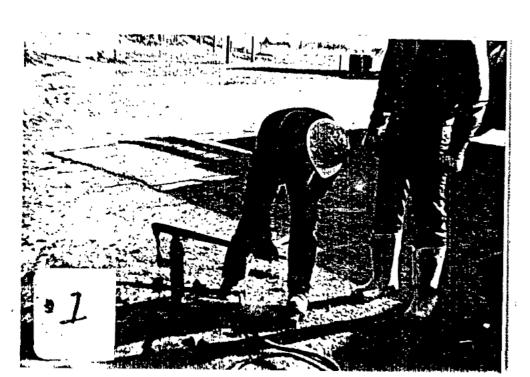
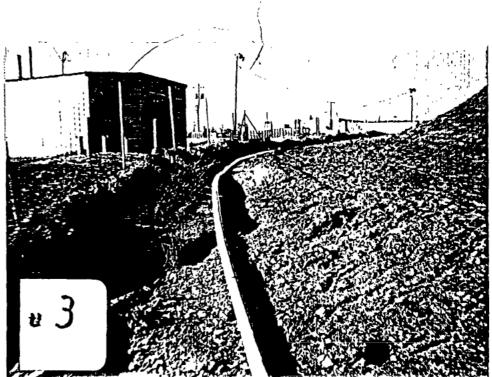
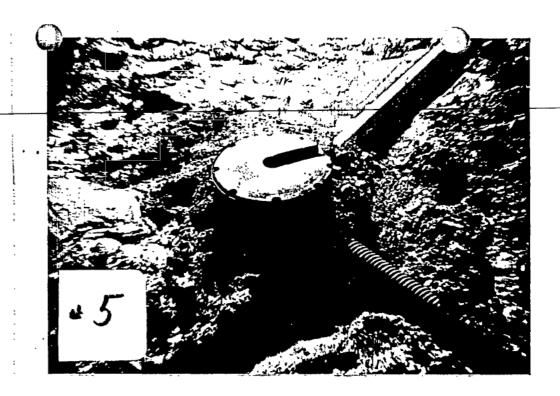
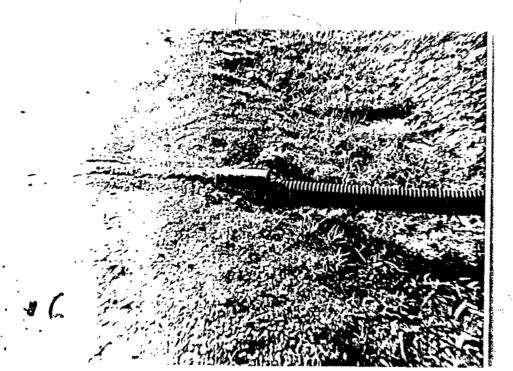
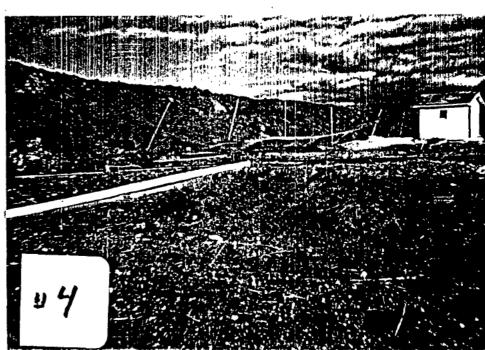
Photographs taken November 11, 1988

fhoto	Description
1 2 3 4 5 6	Fressusce Test Workers Pressure Test Connection On Ground Pipe Line Termination in Contained Area TYP Leak Detection Pot Heavy Wall Steel Protection Under Road
